# RECALL ACTION BULLETIN

Bull. No: A/B/D233

MODEL/DERIVATIVE	AFFECTED RANGE:
Range Rover V8 Automatic models	XA410482 to 1A452817
Discovery Series II Automatic models	XA220000 to 1A299999 1A700000 to 1A713517
Build date range	June 1998 to December 2000

**AUTOMATIC GEARBOX FLUID CONTAMINATED WITH WATER**

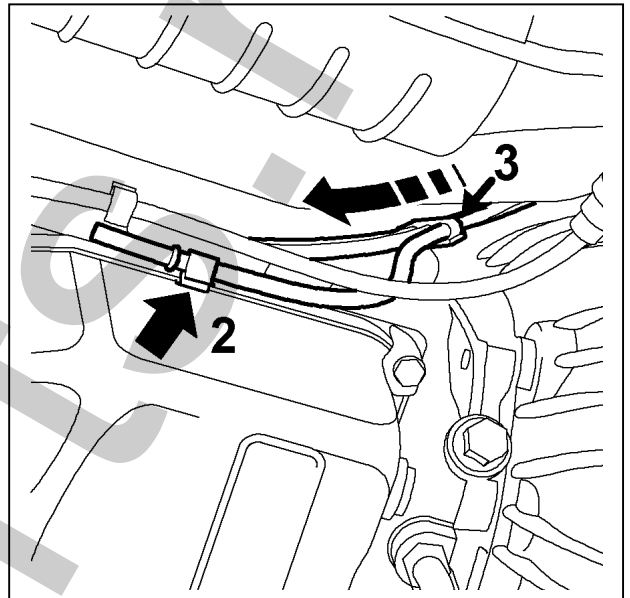
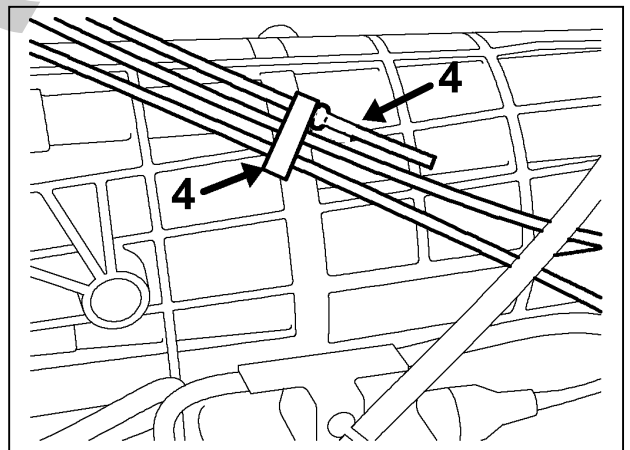
Efflux (liquid condensate) from the air conditioning system runs over the body of the transmission and may pass over the right hand side of the sump flange. The water may then collect on the transmission breather pipe and fall to the ground. Some of the water that remains on the breather tube can then be drawn into the transmission.

The current routing and location of automatic gearbox breather pipe is also below the wading depth of the vehicle and may also in extreme circumstances siphon water into the gearbox resulting in emulsification of the gearbox fluid.

3. Check the breather pipe for damage and that it is free from debris at the open end of the pipe.
4. Locate the white plastic three-way saddle clamp situated above the gearbox bell housing, lightly spray silicon lubricant along the pipes to aid the movement of the saddle clamp.

5. Slide the saddle clamp down the breather pipe. The natural routing of the breather pipe to the left hand side of the gearbox will automatically redirect the open end of the pipe over the top of the gearbox. The saddle clamp must be manoeuvred along the pipe until it contacts the swage on the open end of the pipe.

6. Apply a white paint dot to the top of the fan cowl as a visual indication that this work has been completed.
